Sprayers inspection in Venetian Region: experiences, issues and future perspectives

Cristiano Baldoïn

Dept. TeSAF, University of Padua, Agripolis, viale dell'Universita', 35020 Legnaro Italy

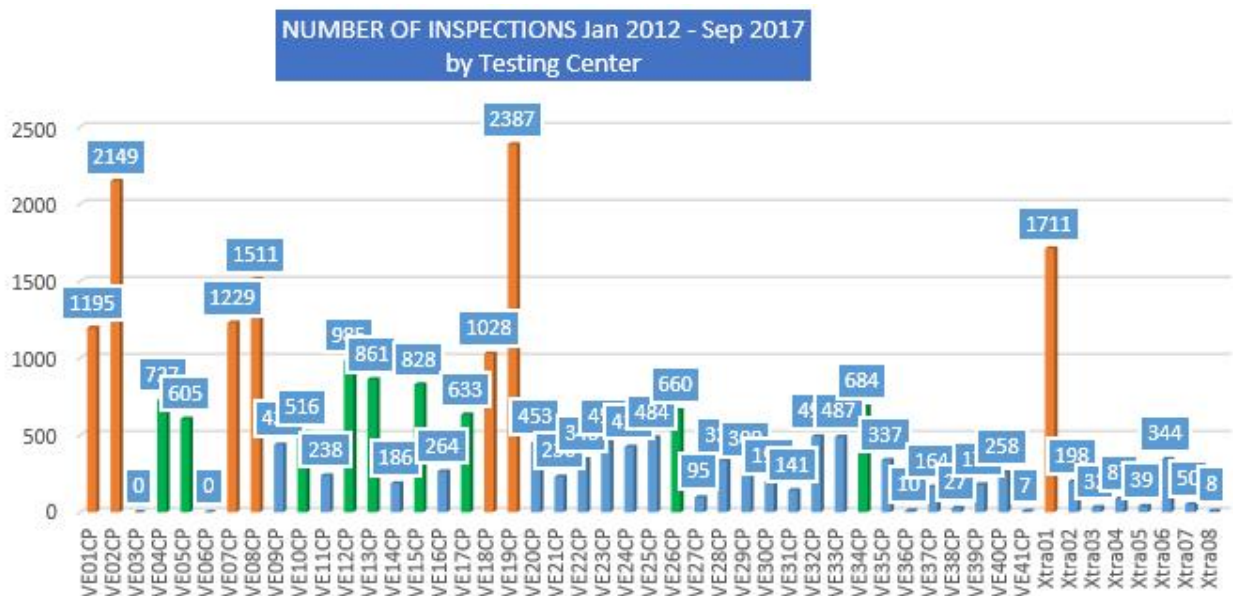
Fig. 2 - total number of inspections carried out in Veneto from 2012 to September 2017

As resulting from the processing of the data transmitted quarterly to the regional authority, 25.004 inspections were carried out as at 30 September 2017, with a sharp increase in activity, as expected, as the deadline set by the NAP approached. This was also due to the Region's decision to restrict the grant of the subsidized diesel fuel for spraying operations to the presentation of the certificate of control.

The elaboration includes the controls carried out by the 41 test centres based in Veneto, and the 11 of other Regions authorized by mutual recognition. An estimate of the percentage of inspections carried out on the total number of sprayers in use on the territory is impossible, as their number is not known; however, considering that many equipment used in small farms have been likely to be abandoned, the result obtained in terms of the number of checks is to be considered more than satisfactory. Figures 2

and 3 show a synthesis of the number of inspections carried out from 2012 to 2017, grouped by testing centre, by province and by type of sprayer.

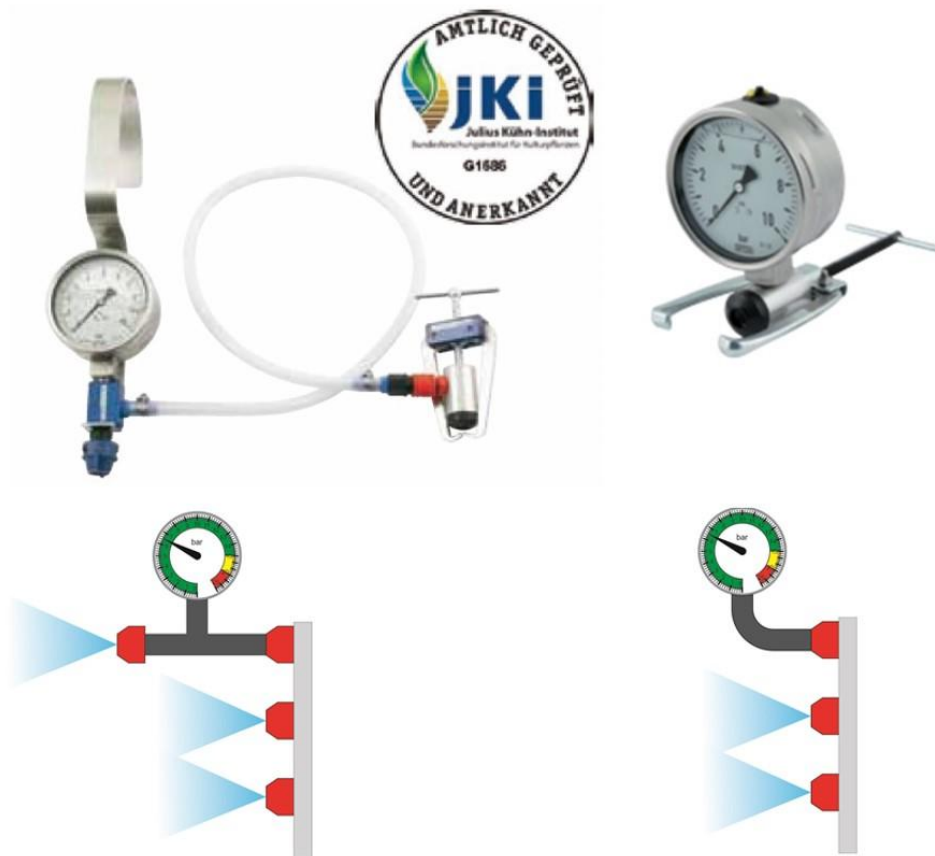
Fig 4 – manometers for measurement of pressure drop

The third issue pointed out by some technicians refers to the method to measure of the pressure drop at the end of the last spraying section; it should be noted that, unlike the old standard, ISO 16122 makes the result of the test mandatory to pass the inspection. However, the test methodology is not specified accurately, merely prescribing the placement of a calibrated manometer *"at the same position as a nozzle at the outermost end of each boom section"* (ISO 16122, part 2 – 3). In this regard, it should be noted that there are two ways to perform this measurement: in fact, the reference manometer can be placed "near" the terminal nozzle or "in place" of the latter, using two different versions of the calibrated gauge, regularly on the market, as shown in fig. 4 (source: AAMS Salvarani catalog).

In the first case, the pressure gauge is placed "near" the terminal holder of the bar section, with the nozzle mounted at the drain of the pressure gauge, while in the second it is placed "in place" of the nozzle, thus occluding the discharge. In general, the pressure gauge placed in line with the terminal nozzle is used more frequently during the functional check of the boom sprayers, but nothing prevents the same method from being used on the orchard sprayers, for example to simultaneously measure the flow rate and pressure drop through a special adapter.

The two measurement techniques obviously provide different results: given the same pressure at the inlet of the boom section, the occlusion of the terminal nozzle by the blind pressure gauge causes a reduction in the overall flow rate of the section proportional to the capacity of the closed nozzle. Consequently, the pressure drop is lower than the measurement carried out with the nozzle mounted. The variation in the value of the pressure drop is not high, but since this test, according to ISO 16122, is required to pass the inspection, it was considered interesting to evaluate if, and possibly, under what conditions, the carrying out the test in one way rather than the other can affect the result.

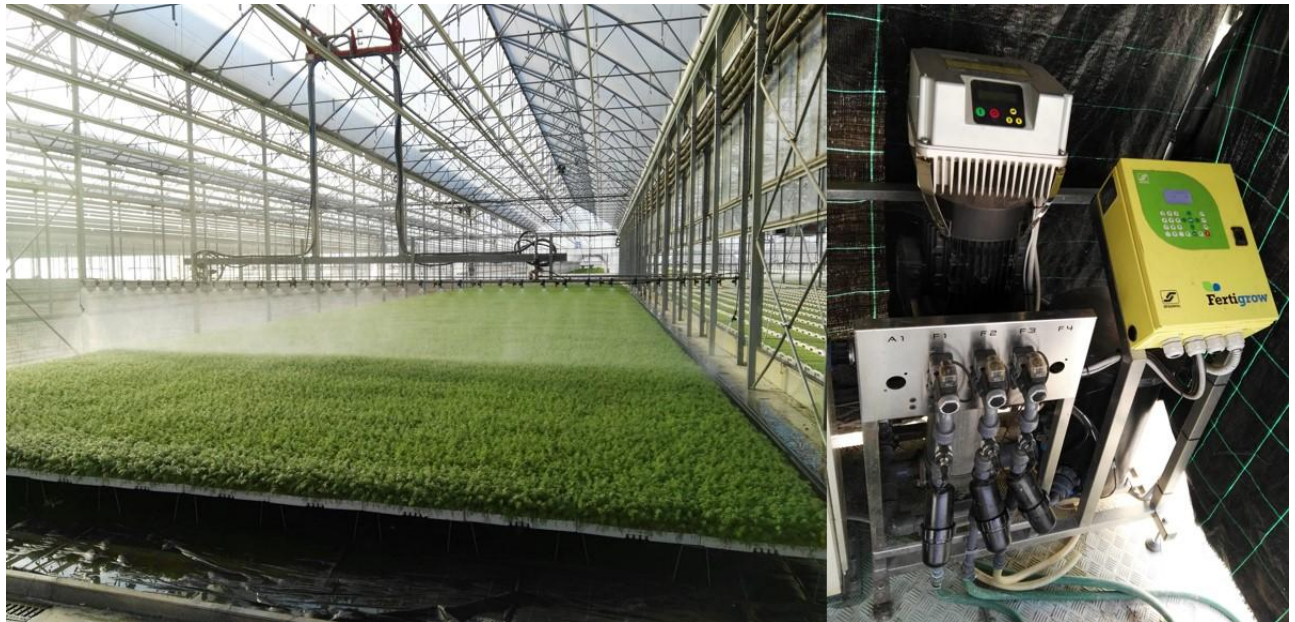
Fig. 5 – spraying equipment in greenhouse and proportional dosing device

For the distribution of plant protection products on greenhouse crops, generally on the ground or on benches, the most common system is based on booms installed on suspended rails that allow the movement along the greenhouse. From a functional point of view, this type of spraying system is completely similar to a generic traditional sprayer for field crops, since the operating principle is identical. The main difference, in addition to the dislocation of the construction parts, concerns the dosing of the pesticide, which does not take place by preparing a diluted mixture contained in the main tank, but is carried out by injecting a concentrated suspension of commercial formulation at the inlet of the boom by a proportional volumetric dosing device (*dosatron*, see fig. 5).

The general layout of the plant generally vary depending on the arrangement of the greenhouse and its dimensions, but in principle it includes a series of "spraying units", each consisting of a group of booms connected to a *dosatron* unit for the distribution of the concentrated phytosanitary mixture. There is not a dedicated tank, as the water comes from the central plant; this one may eventually be equipped with tanks, but they are aimed at preparing the fertilizing solution distributed with irrigation and do not fall, therefore, among the constructive elements to be included in the functional check. It is also noted that often, since the same plant is used both for fertigation and for the distribution of plant protection products, the boom has a double line of diversified nozzles, intended for the two different uses; therefore, in this case the functional check concerns only the dedicated line. With regard to the individual points of the functional check, reference was made to the Enama document no. 6 related to field sprayers, making the appropriate modifications. The first operation concerns the identification of the power supply units and the related spraying elements (modules), generally consisting of one or more bars, each stably located on a lane of the greenhouse; these lanes are, in general, uniquely numbered within the farm, so that this number can be referred to for the identification in the testing report. To facilitate operations, an ad-hoc test report has been prepared, based on the official regional forms for field crop sprayers, taking into account the observed specificities. The report consists of two parts, the first one dedicated to the identification and verification of the main mixing unit, the second one for the collection of data relating to the bars belonging to the main unit; this second form is filled in as a number of copies corresponding to the bars in question. Each test report therefore refers to an autonomous unit, supplied by a mixing group, which will be identified, and eventually stamped by the Test Centre. The stamping can be placed on the frame or on the platform where the dispenser is firmly fixed.
