## **Dust explosions: A report on recent major explosions in Argentina and Brazil**

Hajnal, R.D.\*#

### Abstract

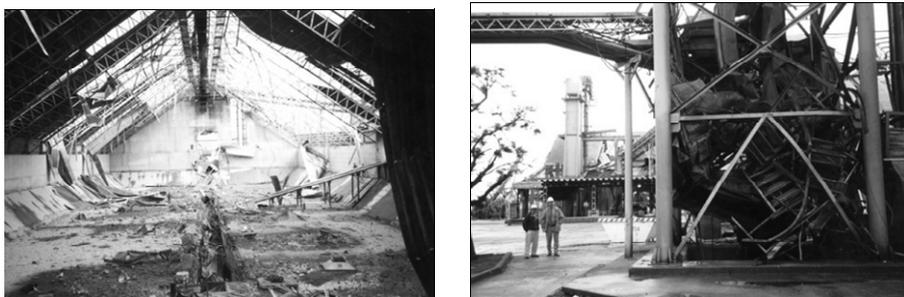
**Figure 1** TOEPFER Puerto San Martín explosion (Santa Fe, Argentina) October, 2001

The first or primary explosion started underneath the steel bins, in the tunnel. Standing dust on the floors and edges was stirred up by the shock wave caused by this primary explosion, and provided the fuel for a secondary explosion, which was much more violent than the first, expanding quickly through the connecting tunnel to the tunnel underneath the warehouse, where the workers were. The warehouse was empty but two workers inside the tunnel were killed instantly and a third, working on the floor of the warehouse, was killed as the concrete tunnel roof blow up. A chain reaction of ever-increasing intensity had been set in motion that culminated with a third explosion that completely destroyed the reception area (about 300 m away from the starting point), and other concrete and metallic structures.

Curiously, the conveyor belt had stopped operating inside the tunnel where the explosion had started one hour before the explosion. Therefore, everything was still and quiet, and there was no dust-air mixture in suspension. An ignition source of sufficient energy, temperature and duration to initiate the explosion had to be present. Without an electrical spark or an overheated bearing in a confined area with fuel, and with no dust in suspension and nothing moving in the tunnel, an explosion seems impossible!

Experts think that the TOEPFER explosion was due to hexane gas rather than grain dust. Since rebuilding of the facility, hexane monitors have been installed in the tunnels which will detect gas leaking into the tunnels under the storage from the crushing plant next door. Steps were taken on both sides to correct this dangerous situation.

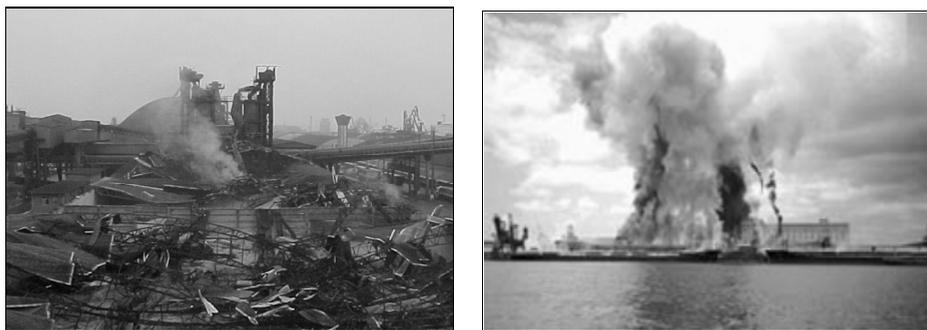
The explosion started in the shipping bucket elevators were in operation, and was most probably due to belt misalignment. This primary explosion expanded quickly throughout the whole facility. The first explosion caused dust within the facility to be blown into suspension in the air, thereby contributing to a series of subsequent much more powerful secondary explosions. The secondary explosion was so strong that all resistant structures collapsed, even rail cars were turned over like toys, big pieces of concrete that weighed over 5 t were blown 300 m away, the steel shipping tower collapsed to earth. The destruction was followed by fire, which ignited the grain and continued burning for nearly three weeks.

**Figure 2** The COINBRA Paranaguá Terminal explosion (Paraná, Brazil) November, 2001

Again the explosion occurred at midday, whilst loading maize onto a ship, so luckily the main personnel were out for lunch, and no one was killed. Nevertheless, six people were injured, and there was massive damage to the facility. The information I have on the causes is acquired from the testimonies of people operating the neighboring terminal, who witnessed the explosion and whose facilities also suffered serious damage from huge pieces of airborne concrete that hit their facility during the explosion (Fig. 2).

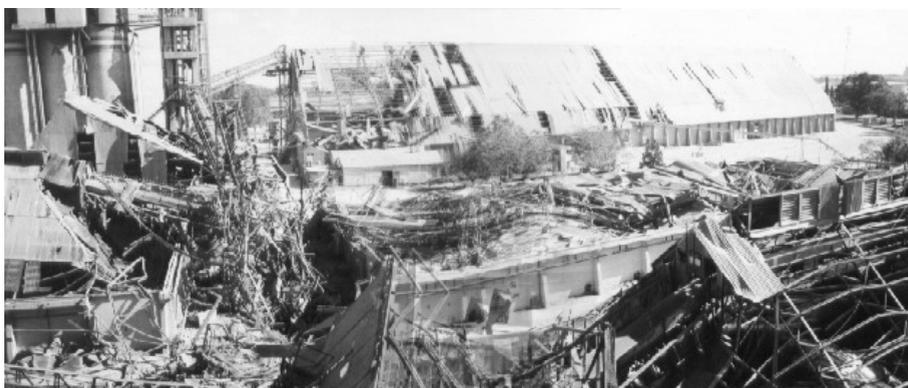
The explosion occurred while loading soya onto a ship on a dry and sunny autumn day. Again, luckily, the main group of personnel was out for lunch. Even so, the explosion left three dead, nineteen injured, and caused massive destruction of the terminal (Fig. 3). They had been loading a ship that was receiving simultaneously from three spots: from the horizontal silo, directly from trucks through the receiving pits and directly from railcars

**Figure 3** The San Lorenzo Terminal explosion (Santa Fe, Argentina) April, 2002

All three spots were connected through a tunnel that collected from the horizontal silo, passed through the truck reception pits, through the railcar pits and continued to the shipping header house tower that supported the shipping-bucket elevators. This header house was built on a concrete structure, but with no walls, that could have helped to stop or deflect and dissipate the power of the destructive explosion energy wave.

An unknown ignition source ignited dust within the facility and resulted in a series of explosions that severely destroyed the heart of the port facility. The actual ignition source may never be known due to the damage that occurred in the tunnel beneath the horizontal silo, where the first or primary explosion started, and because the employee working in this area at the time of the explosion was killed.

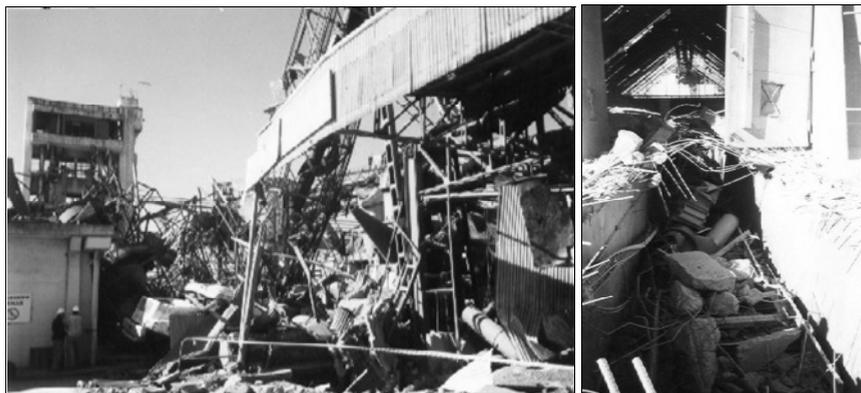
**Figure 4** The San Lorenzo Terminal explosion (Santa Fe, Argentina) April, 2002

This underneath tunnel in the flat storage, connected to another underneath collector tunnel, an underground avenue that led to the shipping tower. The collector tunnel collected grain from the truck reception area, from other tunnels under other horizontal warehouses and from the railcar reception area arriving to the bucket elevator pits in the shipping tower.

This underground infrastructure was a long network of confined spaces that distributed and accelerated the propagation and intensity of the explosion. A second worker was killed while operating the railcar gates and a third was found dead 3 days later in the shipping bucket elevator pit, 15 m below ground level, were the shipping tower stands.

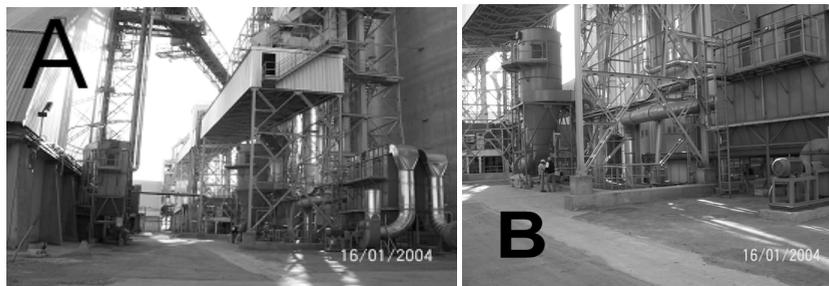
**Figure 5** San Lorenzo terminal reconstruction: A. Open steel galleries above ground. B. Some of the 33 large aspiration systems with filters (bag houses) and open elevator pits

- Eliminating tunnels where possible and instead using open galleries and catwalks that operate above ground, loaded by new bucket elevators at the end of each horizontal warehouse.
- Confining the risks to certain sectors by installing a bucket elevator at the end of every tunnel, eliminating connections between tunnels, avoiding the propagation of the explosion.
- All the mechanical handling is now fitted with hazard monitors, controlling speed, belt misalignment, belt slip, plugging and maximum belt extension, with emergency stop.
- The elevator towers are open and made of steel. Elevator pits are also open.

- Replacing cyclones with low pressure filters (bag houses).
- Adding thirty three aspiration systems with filters (bag houses), that collect the dust emitted during operations, in different sections of the facility.
- Installation of a white mineral oil application system for dust emission control.
- Installation of dust suppression systems in two of the four ship loading tubes, with telescopic hoses, minimizing the dust emission during loading of a vessel.

By reducing belt speeds and increasing capacities, with wider belts to reduce dust generation. For example: Previously the shipping belt ran at a capacity of 1000 t/h at 400 m/s. By comparison, in the new facility the same conveyors run at a capacity of 1200 t/h at 300 m/s.

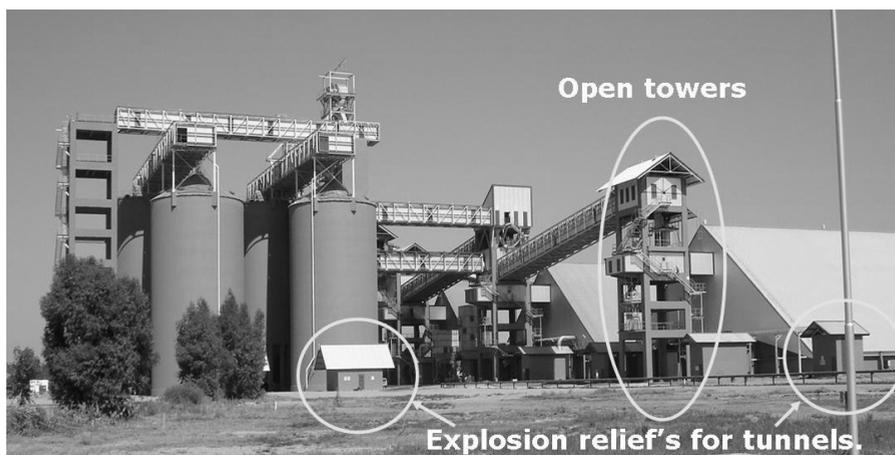
**Figure 6** Open towers and explosion reliefs for tunnels.

Modern plants are constructed with extended lay-outs, to avoid elevators and confined spaces where possible, but some will always exist out of operational necessity: bucket elevators, tunnels under silos, linking tunnels, etc. It is very difficult to prevent an explosion. However, it is always possible to minimize the damage by designing light open structures and explosion reliefs that can dissipate the pressure created by a 'primary' explosion. Using openings that act like vents to prematurely dissipate the initial pressure wave and avoid its destructive and lethal propagation.

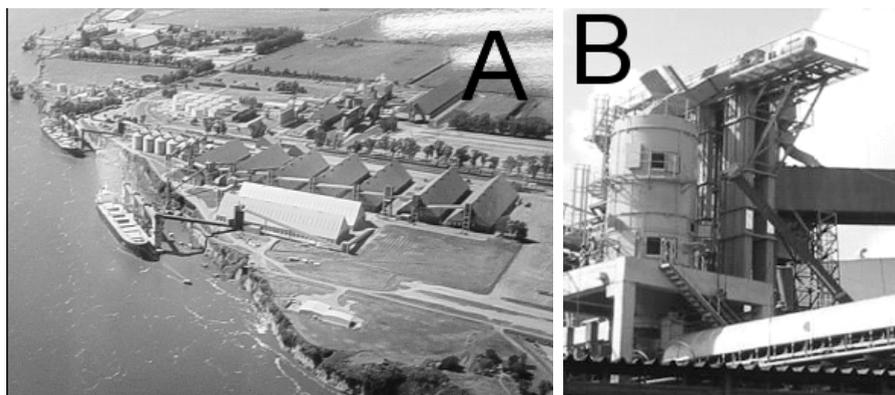
**Figure 7** A. Facility with extended tunnel conveyor lay-outs with no elevators, B. Filter bag houses.
