Guidance for the Management of contaminated soil

Beate Alberternst, Stefan Nawrath

DOI 10.5073/jka.2016.455.21

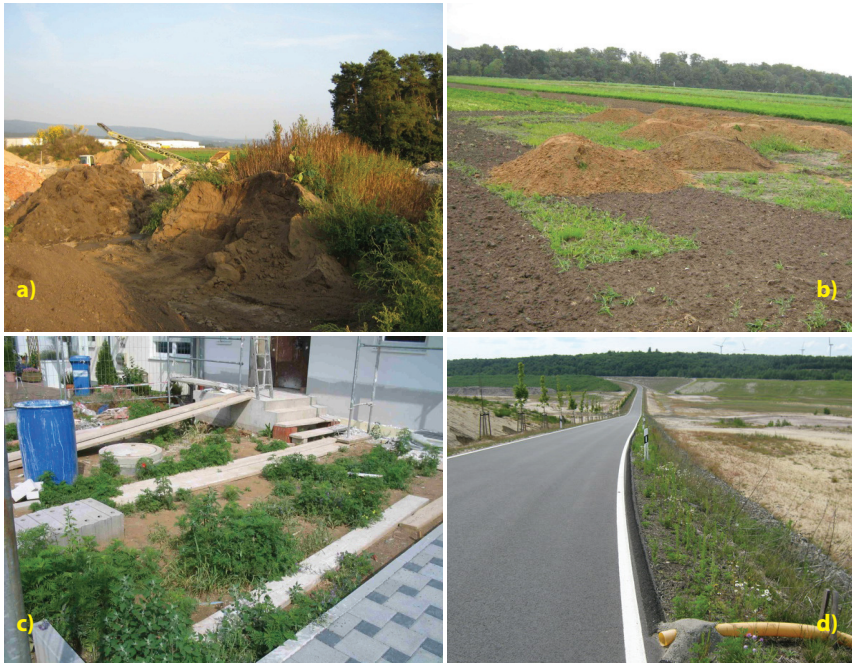
Fig 4: Pathways of spreading for ragweed with excavated material.

a) Soil depot with ragweed occurrence, Strullendorf, Bavaria, 29th Oct.2009

b) soil disposal at an onion field, Griesheim, South Germany, 29th July 2007

c) construction site with ragweed occurrence, Griesheim, 27th June 2006

d) ragweed occurrence at the sides of a newly built road in a reconstructed mining area near Senftenberg, East Germany (10th July 2011).

A. artemisiifolia achenes can be transported within excavated material over long distances and can reach new growing sites and areas far away from the initial seed source. From own investigations in Germany we learned that soil excavated at a construction site is often not directly used for construction work at other places but deposited at special sites and used later (Fig. 2). Soil depositions often provide suitable growing conditions for pioneer species such as *A. artemisiifolia*, like disturbed, sunny vegetation-free sites where these species can grow and produce seeds. A great amount of soil can be infested with common ragweed seeds at the deposition sites when contaminated soil is mixed with common ragweed-free material. Contaminated material can be dispersed widely during construction works, and by this way common ragweed can be introduced to many new locations (Fig 4 c, d, Fig 2).

In some cases soil from construction sites is disposed at agricultural fields (Fig 4 a, b). If the soil is contaminated with ragweed seeds the species can be introduced there.

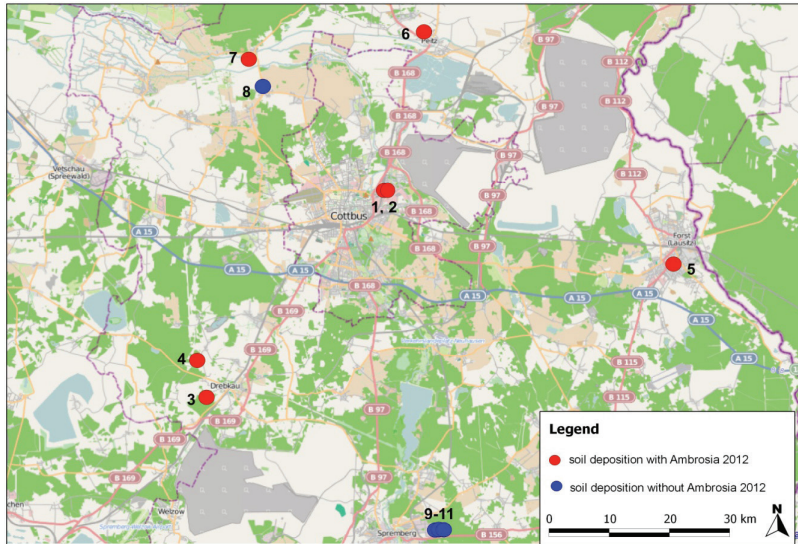
Fig 7: Location and number (compare Tab 1) of the transient soil depots investigated for ragweed occurrence in the Niederlausitz near Cottbus, East-Germany, September 2012.

Ambrosia artemisiifolia was found at 7 of the 11 (63.6%) transient soil depositions investigated in this study (Tab 1, Fig 7).

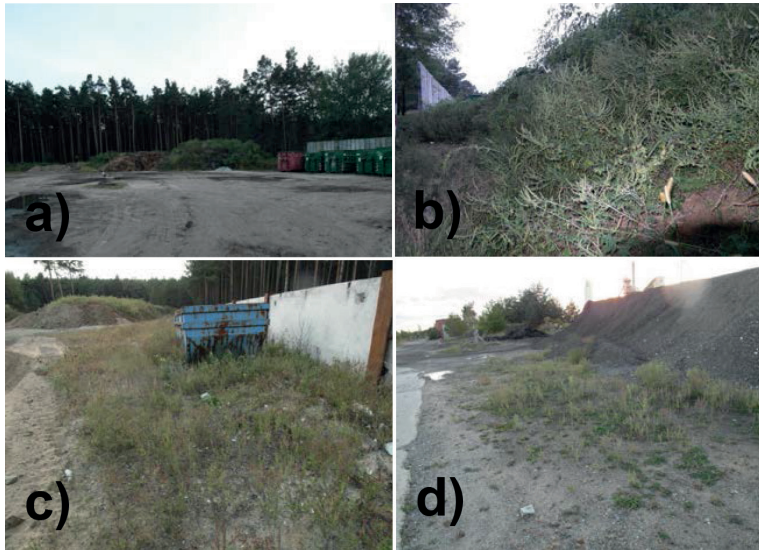
Fig 8: Common Ragweed occurrence at transient soil depot in Drebkau (a-c) and Cottbus (d), Sept 2012.

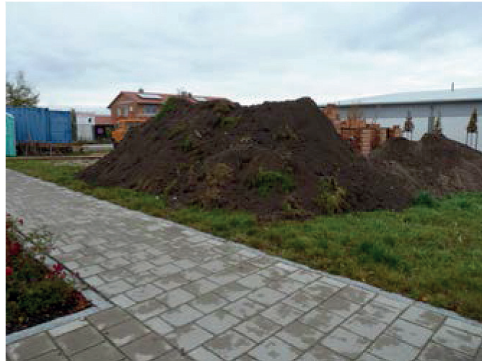
Fig 10: Excavated soil at the construction site „Am Falkenhorst“ in Hiltpoltstein.

In 2007 extensive ragweed occurrences grow at this construction site. Excavated material from here was transported to the transient soil depot in Hiltpoltstein.

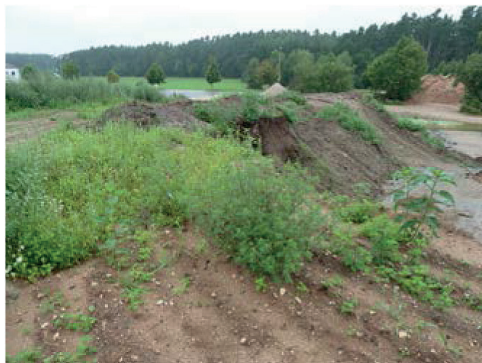
Fig 11. Soil depot with ragweed occurrence in Hiltpoltstein in Bavaria.

The transient soil depot received soil from a construction site nearby (“Am Falkenhorst”) that was built on a former cut-flower field. Sunflowers from bird seed that was used for sowing material were cultivated here.

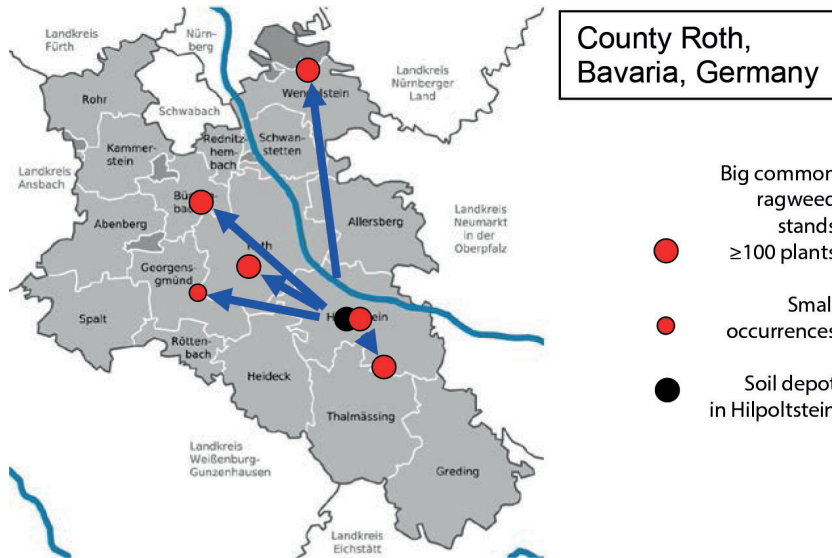
Fig 12: Transient soil depot in Hilpoltstein (black dot) that could be detected to be the origin of six new common ragweed stands (red dots) in the county Roth, Bavaria (Germany) in 2012.

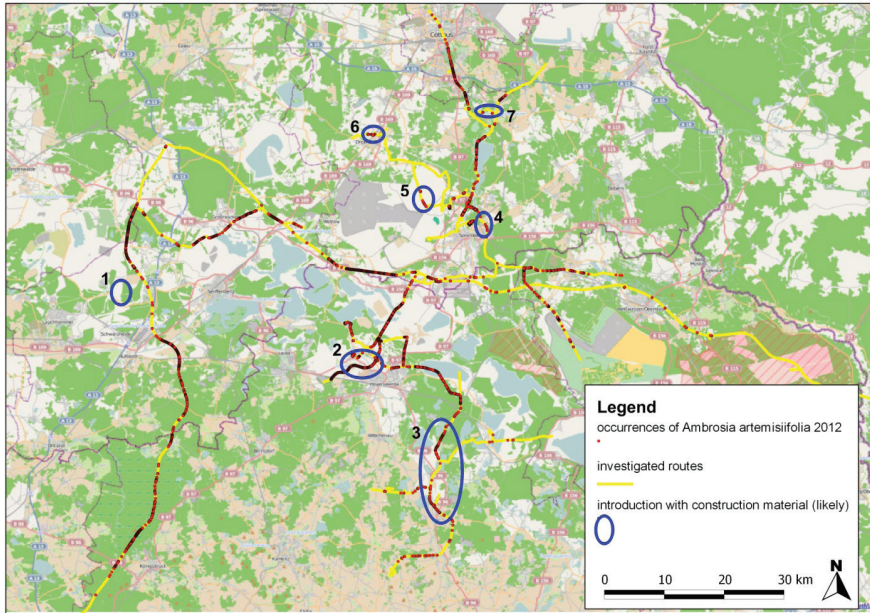
Fig 13: Occurrence of common ragweed at road margins in the Niederlausitz near Cottbus, East-Germany, September 2012.

Marked in blue: Ragweed occurrence at newly built roads and at roads with new hard shoulders. *A. artemisiifolia* was most probably introduced here with the construction material (Tab 2).

In Tab 2 (compare Fig 13) newly built roads and roads with rebuild banquets are listed. At these sites ragweed plants were found during the investigations in 2011 and 2012. Ragweed was introduced here likely with contaminated soil. Two of these roads are described more precisely below.

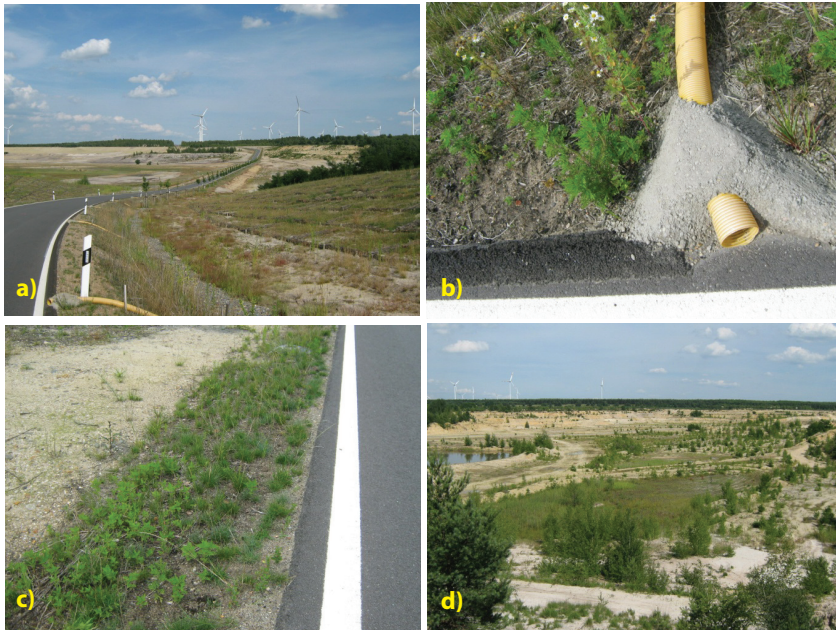
Fig 15: Newly built road in a reconstruction area connecting the villages Klettwitz and Kostebrau near Senftenberg (photo: 2011/07/06).

a) Newly built road in a reconstructed mining area.

b) Common ragweed occurs predominantly at the road side where brown humus was brought in while on the opposite road side no or less of this substrate was used.

c) Road shoulder of the new road. Here a substrate rich in humus was used. Ragweed plants occurred here.

d) Vegetation-poor reconstruction area which is not allowed to enter. Looking from the road in this area, no ragweed plants were detected. The plants only occurred at the road margins.

At the roadside where the ragweed plants occurred, a humus-rich material was used to fill the hard shoulder (Fig 15). At the opposite side of the road no or only less of this material was used. The road runs through an open, vegetation-poor area which provides good conditions for the pioneer species *A. artemisiifolia*. Unfortunately it is not allowed to walk in the reconstruction area. So only the margins of this region could be inspected (Fig 15). In the visible area, ragweed plants were only registered at the margins of the road but not in surrounding areas. This indicates that *A. artemisiifolia* was not introduced from the surroundings and supports the observation that ragweed was introduced with the humus-rich material used to fill in the road margins.

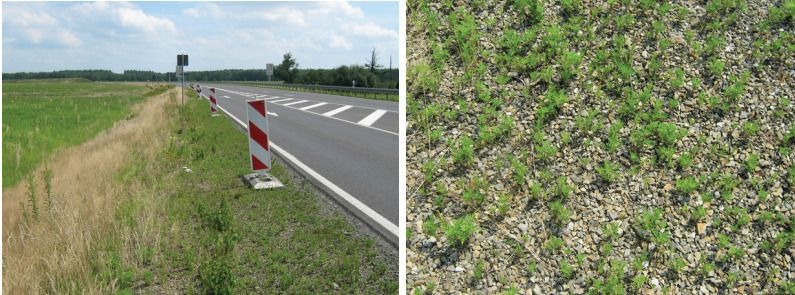
Fig 16: B169 near Domsdorf. At the margins of this newly built road millions of ragweed plants are present. Ragweed was probably introduced here with construction material and dispersed during the construction work (photo 2011/07/10).

The newly built road B169 which bypasses the city Drebkau over a length of 8 km was opened in December 2009 (BMVBS 2009). At this road millions of ragweed plants occurred in 2011 and 2012 (Fig 13). *Ambrosia artemisiifolia* was introduced here probably with construction material and spread quickly over the last few years.

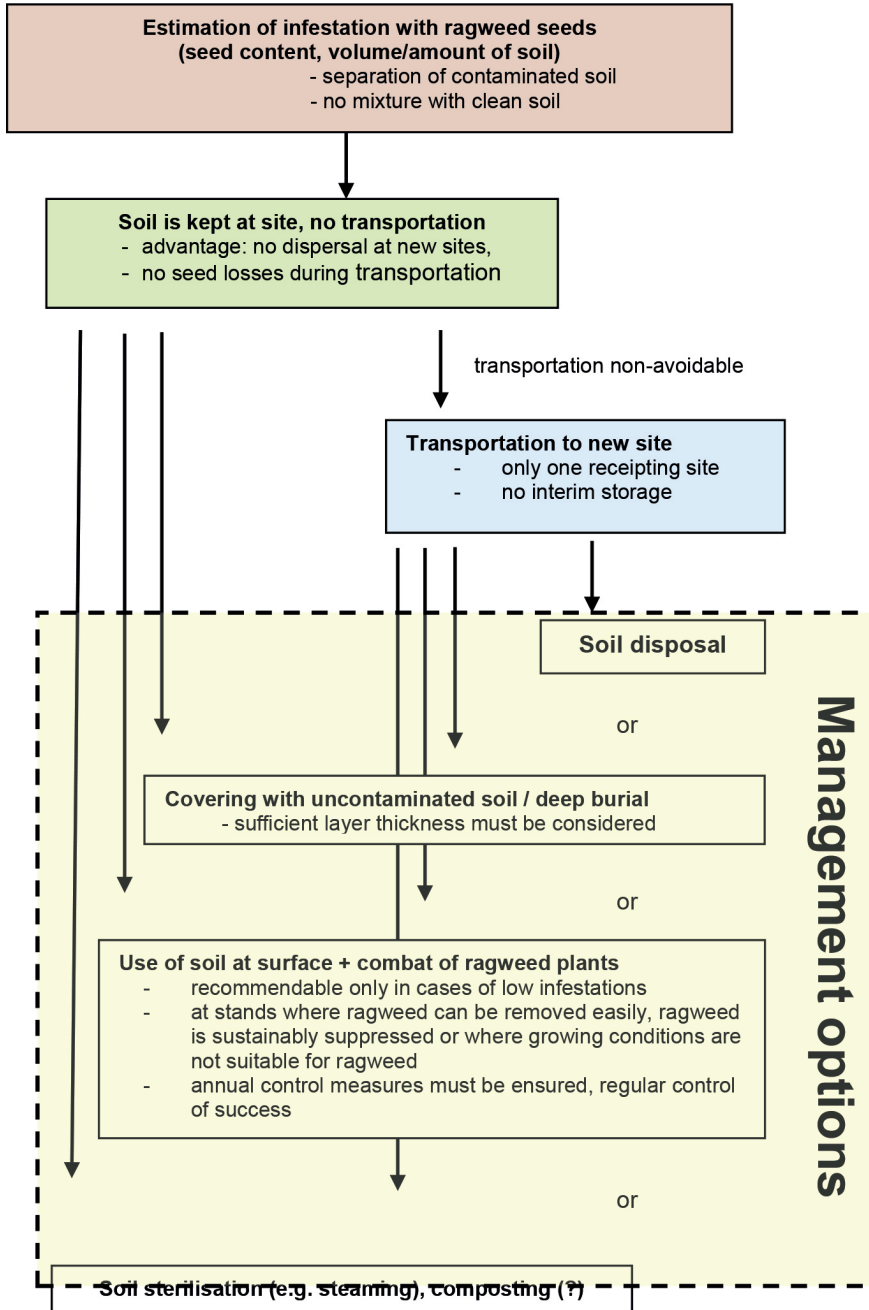
Fig 17: Options to prevent the spread of *A. artemisiifolia* in contaminated, excavated material.

Excavated material should be kept at the same site and it should be separated in order to avoid a contamination of clean material (see Fig 17). Newly grown ragweed plants should be removed before seed set. A cover of the contaminated soil piles with a foil could help to prevent germination and seed set of *A. artemisiifolia* plants. If possible, the contaminated soil should be used for fillings below the surface. If this is not possible, the material should only be used in areas where a combat of *A. artemisiifolia* is ensured over several years until no ragweed plants grow up any more. A control of success is necessary. If it is not feasible to keep the soil at the same site, the material could be transported to a location where it is used in civil engineering processes and is deeply buried. Instead of burying, the soil could also be used for construction work in areas where no suitable growing conditions for the species are present (e.g. varnished areas, intensively used grassland). A mixture with uncontaminated soil should be avoided and the material should only be transported to a single site in order to prevent an allocation at different locations.

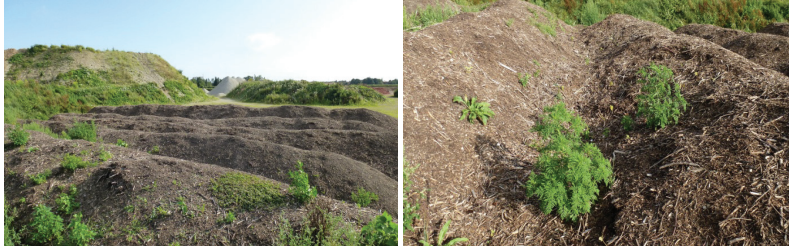
Fig 18: Piles of composted material near Salmdorf, Bavaria, 2012/07/18. Four living ragweed plants were found on top of the piles.

In Baden-Württemberg, South Germany, soil containing rhizomes of the invasive Japanese Knotweed (*Fallopia japonica*) is composted in order to kill the rhizomes. The knotweed contaminated soil is enriched with fresh compost and afterwards composted at a temperature of 70 °C. During the composting procedure it is necessary to relocate the compost 6 to 8 times (Email B. Walser 2012/12/18). This measure might also be used to decontaminate soil containing ragweed seeds. In trials it should be ensured that the ragweed seeds were already killed by this method. If the temperature is not high enough, ragweed can survive the composting procedure as it was observed in Bavaria in 2012, where in July 2012 four vital ragweed plants were found on piles of composted material (Fig 18).
