The inspection of soil-disinfection equipment in Belgium.

Summary.

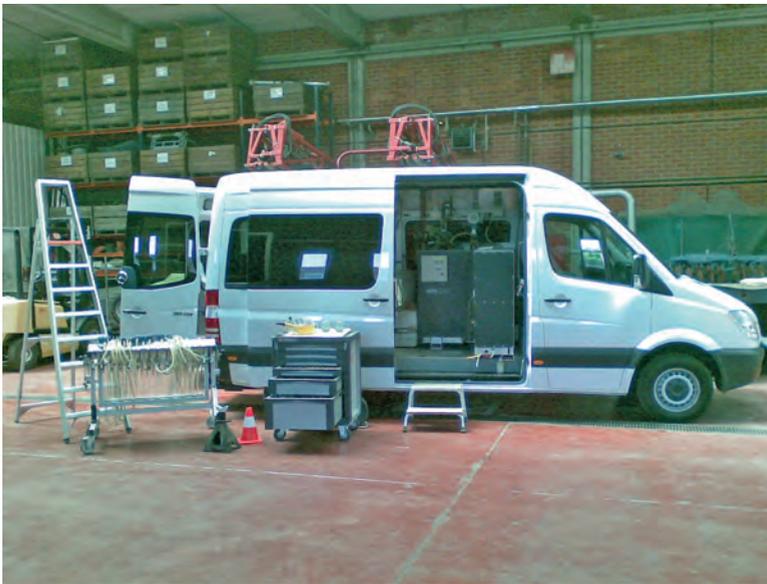
Fig. 1. Inspection van with test equipment.

credited according to ISO 17020 which guarantees a maximum quality of the performed inspections. The inspection teams (3 in the Flemish region and 2 in the Walloon part) are equipped with a test van that contains all necessary equipment to perform the inspections according to the Belgian federal legislation (Fig. 1). The inspections are carried out at a neutral location where farmers/contractors are invited at an exact date and time, to present their sprayer for testing at this place. All over the country test locations are hired in a way that farmers/contractors don't need to travel distances > 15 km with their sprayers. On demand inspection teams also perform inspections at the farmyard, but therefore an extra fee is charged. The inspection procedure is based on the analytical principle which means that all parts of the machine are tested separately. After the inspection the farmer/contractor receives a certificate confirming the approval of the sprayer for the next three years or specifying all the items that need to be repaired in case of a rejection. No repairs are made to the sprayer during the inspection, so the farmer/contractor needs to repair the defects himself or leave the repairs up to a workshop. Consequently, the repaired sprayer has to be represented for a second passage.

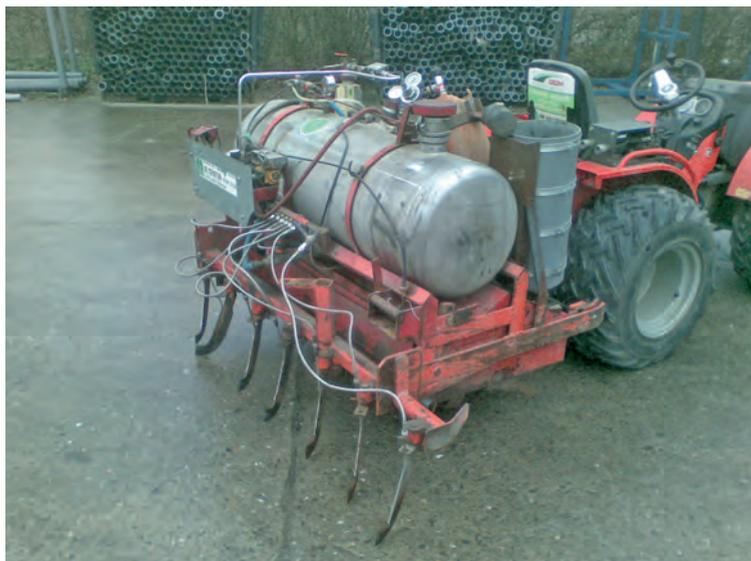
Fig. 2. Typical soil-disinfection machine.

In order to clarify the inspection protocol, one first needs to know how this type of machines work (Fig. 2). Therefore a hydraulic scheme is useful and a simple scheme is shown in Fig. 3 containing all elementary parts of a common used soil-disinfection machine.

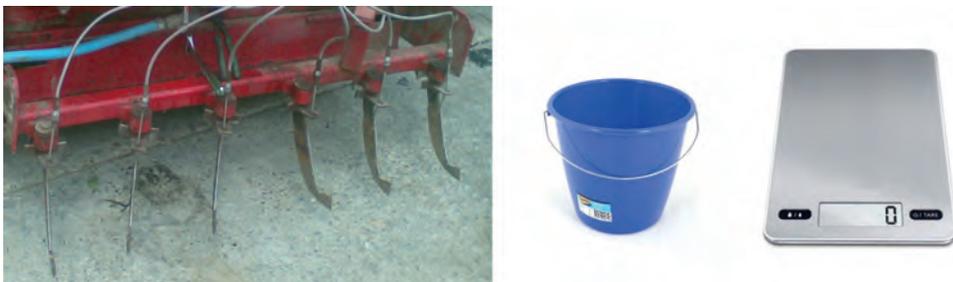
At first, pattern testing was performed with graduated measuring cups and a stopwatch as sometimes performed on normal field crop sprayers. Disadvantage of this method is that some of the injectors are very difficult to reach and with two inspectors only 3 injectors at a time can be measured. Furthermore while inspecting, the inspectors are close to the outflow of the injectors, and in some cases need to position arms underneath the machine what makes this an unhealthy and unsafe situation.

Fig. 4. Soil-disinfection machine injectors, pattern measurement.
